Owner Service Advisory SA 08-03

SUBJECT: Release of Tornado Alley Turbo Service Bulletin TAT SB08-01

Service Bulletin

TAT SB08-01

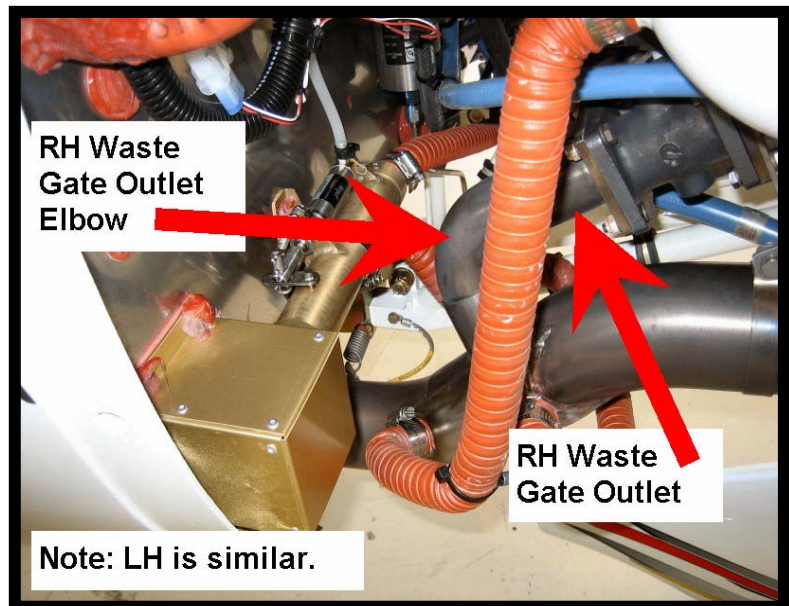
This Service Bulletin contains procedures to modify the right hand exhaust elbow (Group A) and both the right hand and the left hand exhaust elbow (Group B). This exhaust elbow is inserted between the tailpipe and the wastegate outlet fitting. See Figures 1 & 2.

Figure 1. Right side shown.
Left Side Similar.

- b. Visually locate the wastegate outlet on the aft side of the right hand wastegate. See Figure 1. Disconnect the heater hose clamp and hose from the intercooler to facilitate inspection and access.

- c. Visually inspect the right angle exhaust elbow and the area where the elbow inserts into the tailpipe, for any signs of a crack in the weld of the vertical receptacle in the tailpipe into which the short leg of the right angle elbow is inserted. If any cracks are observed, then contact Tornado Alley Turbo, Inc. for replacement parts before return to service or further flight.

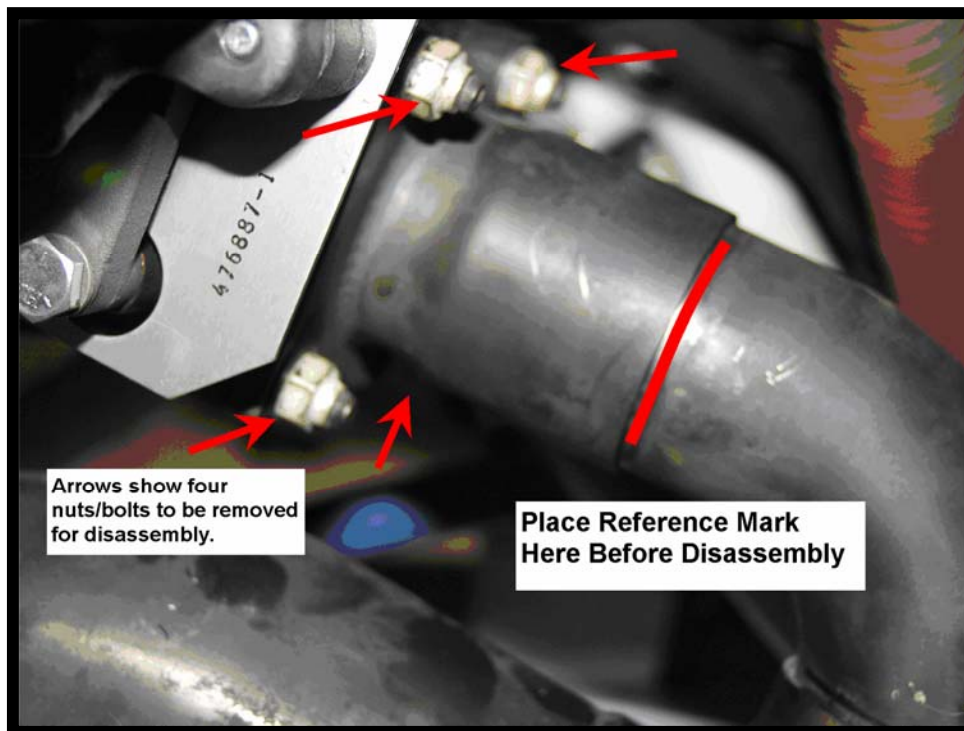
Figure 2.
Left side.
Showing where to place reference mark before disassembly.

- d. Clean the area where the elbow is inserted into the wastegate outlet tube.
 - e. Mark the exhaust elbow at the aft end of the wastegate outlet tube.

- i. Measure the length of the elbow from the previously applied reference mark to the end of the long leg of the elbow.
 - j. If this measurement is greater than 1.00", shorten the elbow so that the engagement, when re-installed, will be no more than 1.10" and not less than 1.00" as measured from the reference mark.
