Service Bulletin

TAT SB07-01

Model SR22 w/ Turbonormalizer

The purpose of this Service Bulletin is to inform affected owners and operators of a product improvement to the Turbonormalizing System that requires the installation of a support bracket for the wastegate control linkage and possible replacement of attaching clevis pins.

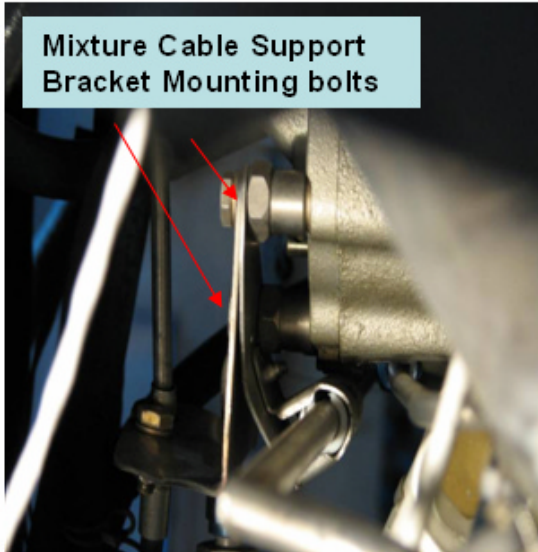
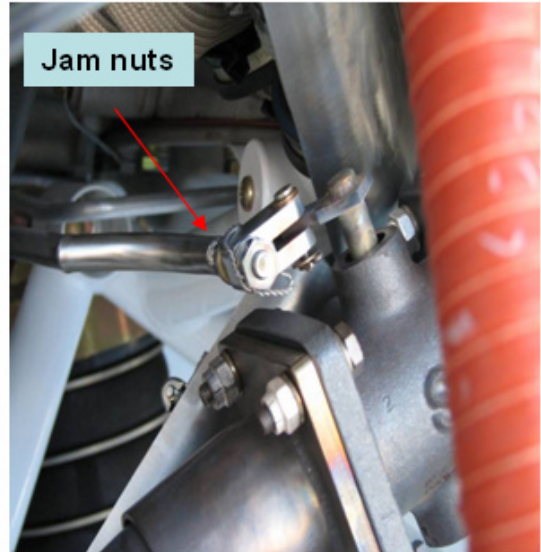
- Gain Access to the mixture cable support bracket and locate two (2) bolts identified below.

- Remove the 2 bolts that secure the mixture control cable bracket to the starter drive adapter.
 - Place wastegate linkage support bracket between the mixture bracket and starter drive adapter and reinstall bolts.

- Torque bolts **50 to 70 inch lbs (5.6 to 7.9 Nm)**.
 - Hand actuate the linkage to ensure freedom of movement.
 - If the linkage rod is not closely aligned with the support bracket and movement of the linkage is not free, loosen the jam nuts on each end of the linkage to allow the linkage to rest neutrally within the support bracket and retighten the nuts and secure with safety wire.

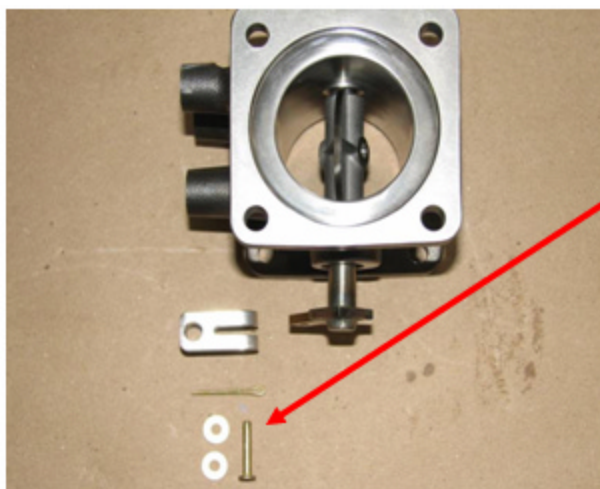
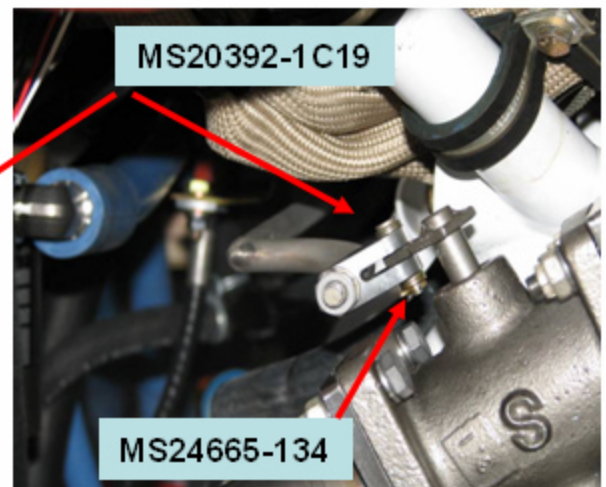
3. If the aircraft **has more than 60 hours time in service**, also perform the following:
 - If the aircraft has more than 60 hours time in service since installation of the Turbonormalizing System, then prior to installing the new wastegate linkage support bracket ETI-G2-112-1, inspect for possible wear to the clevis pins MS20392-1C19 caused by linkage flapping, as follows:

- Inspect the pins at both wastegates by removing cotter pin and sliding pin out. Be sure to retrieve the washers.
 - Replace the pin with new, regardless of condition.

- Note the condition of the clevis hole and wastegate arm. Some wear is normal and is acceptable.
 - Install new clevis pin with 2 washers, and new cotter pin MS24665-134.

- If any excessive wear is noted, contact Tornado Alley Turbo for further instructions.
 - Place old clevis pins in the envelope included for mailing to TAT, and include information as to the aircraft registration number, date, & time in service in the place provided on the back of the envelope.
