# Service Bulletin

**TAT SB09-01**

Model SR22 w/ Turbonormalizer

Installed per STC SA10588SC

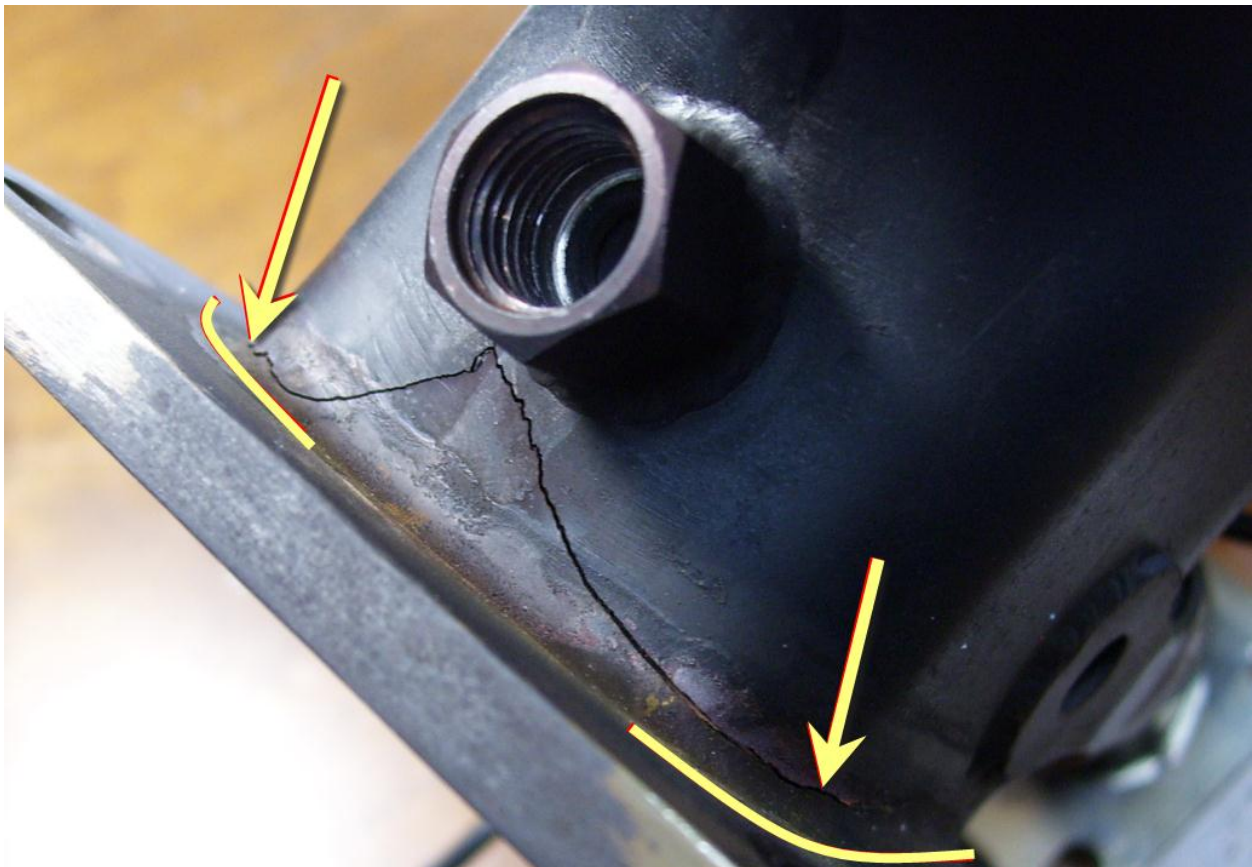
The purpose of this Service Bulletin is to instruct owners of Turbonormalized Cirrus Design SR22 Series airplanes to have the exhaust manifolds inspected for cracks around the turbo mount flanges. (See Picture)

Inspect corners and radii indicated by the arrows.

- While cowling is removed, use a flashlight and inspection mirror to inspect the right and left exhaust manifolds for cracks around turbo mount flange.
- If cracks are found replace exhaust manifold in accordance with Instructions for Continued Airworthiness, Report 22-6460004.
