Service Instruction

TAT SI11-01, Revision A

Model SR22 w/ Turbonormalizer

Exhaust system inspection, cleaning, and lubrication

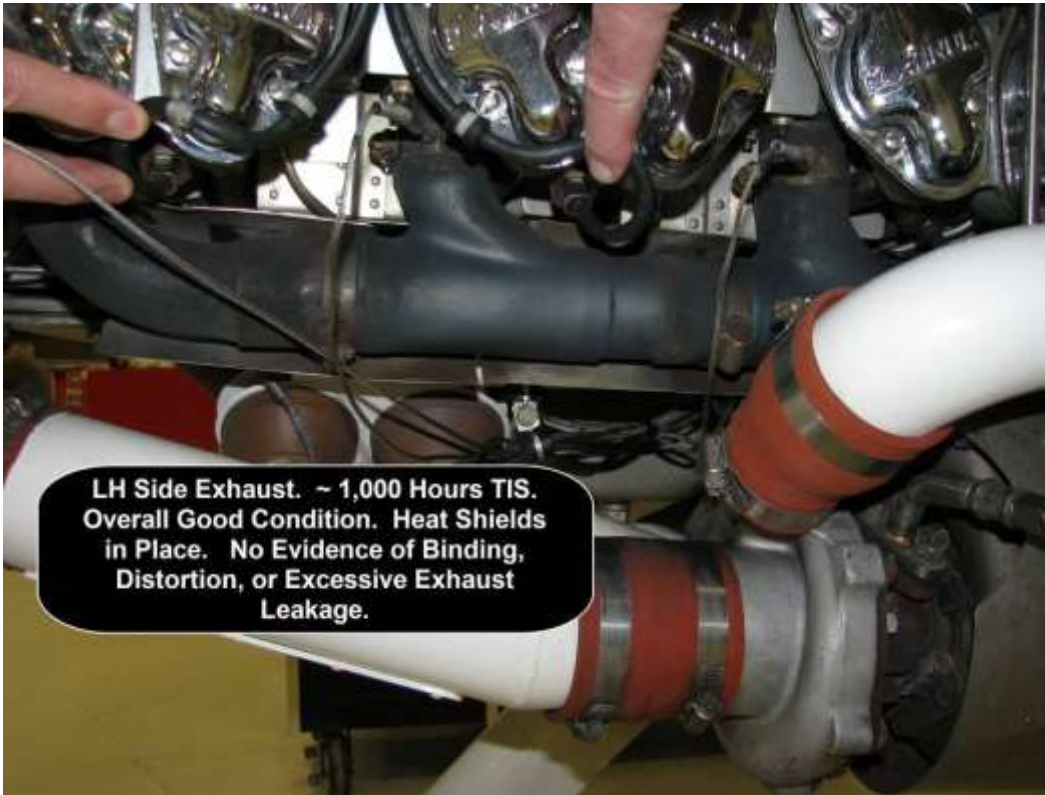
**LH Side Exhaust. ~ 1,000 Hours TIS.
Overall Good Condition. Heat Shields
in Place. No Evidence of Binding,
Distortion, or Excessive Exhaust
Leakage.**

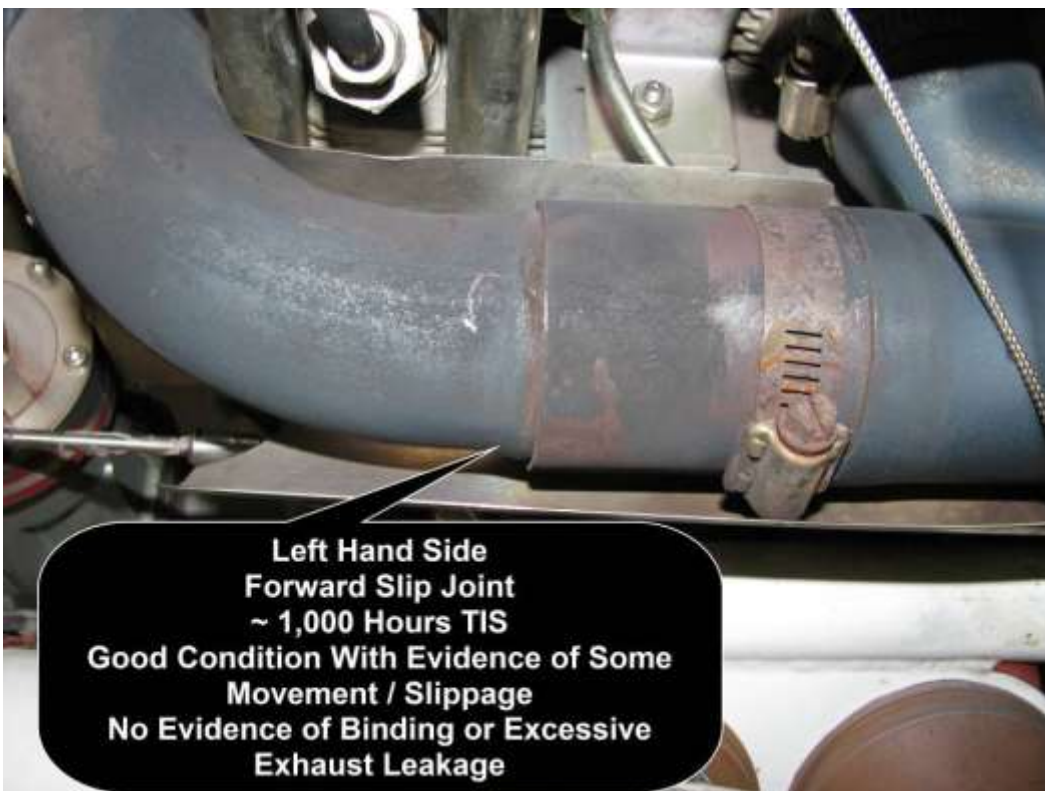
**Left Hand Side
Forward Slip Joint
~ 1,000 Hours TIS
Good Condition With Evidence of Some
Movement / Slippage
No Evidence of Binding or Excessive
Exhaust Leakage**

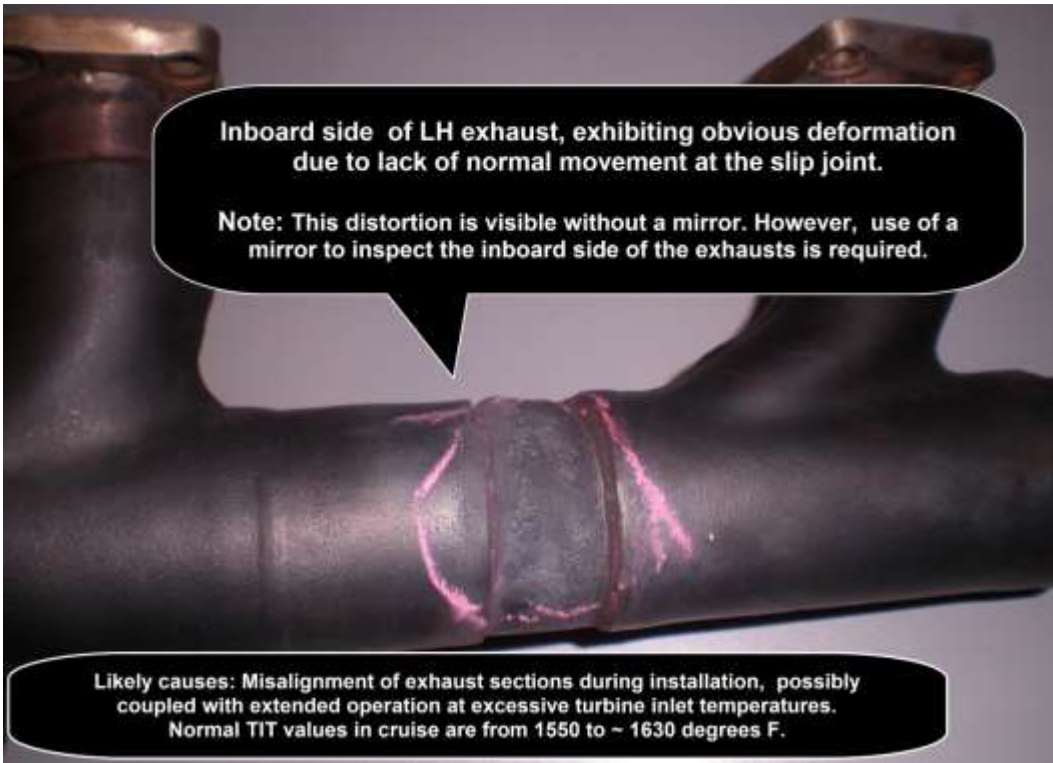
An example of a binding slip joint:

2. If inspection of the exhaust system shows signs of one or more slip joints binding, disassemble the exhaust as required to gain access to the binding slip joint(s) and clean them as outlined in the Cleaning Instructions below. Damaged exhaust components must be replaced with new or serviceable components.
