Service Bulletin

Bulletin No. 040

Issue Date: Nov. 9, 2010

TURBOCHARGER CHRA CONTAMINATION

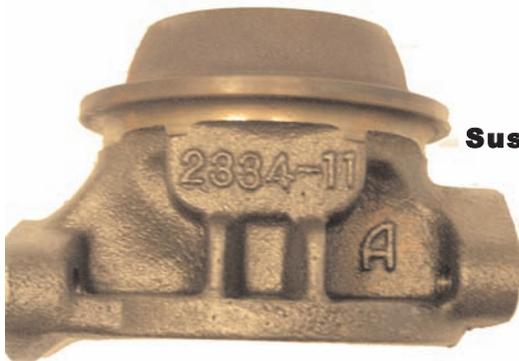
Figure 2 - Foundry Mark "Slanted A"

3. Using Figures 2, 3, and 4, identify the foundry mark located on the CHRA center housing as shown. Those with a circled "JT" are not affected and may proceed to the "Return to Service" section step 3 & 4. If a "slanted A" appears, continue with the DISASSEMBLY and CLEANING sections.

Suspect

4. If it has been determined that the CHRA center housing is affected per Table 1 and IDENTIFICATION section above, the turbocharger must be removed and disassembled to isolate the CHRA center housing.
5. Utilizing the most current Service Manual or Service Instructions of the applicable engine or airframe manufacturer, remove the turbocharger from the engine. To avoid the possibility of debris entering the turbocharger system connections, cap all open lines and ducts.

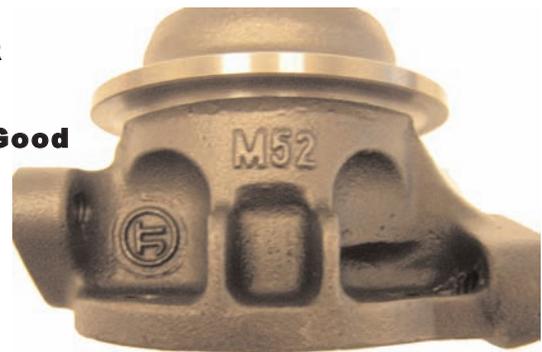
Figure 3 - Foundry Mark "JT"

Good

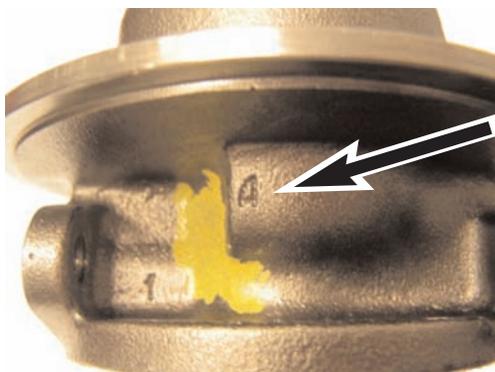
Foundry Mark May Also Be An Indented "Slanted A"

Suspect
