Service Bulletin

TAT SB11-07, Revision None

Cessna Aircraft Company Model 177RG with turbnormalizer system installed per STC's SA4081NM and SE4082NM

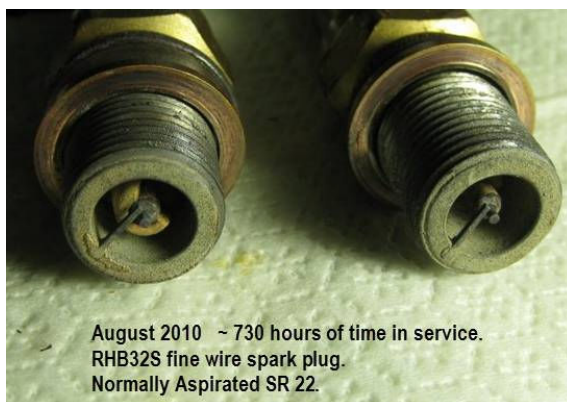
Figure 1. An example of two cracked fine wire RHB32S spark plugs from one engine.

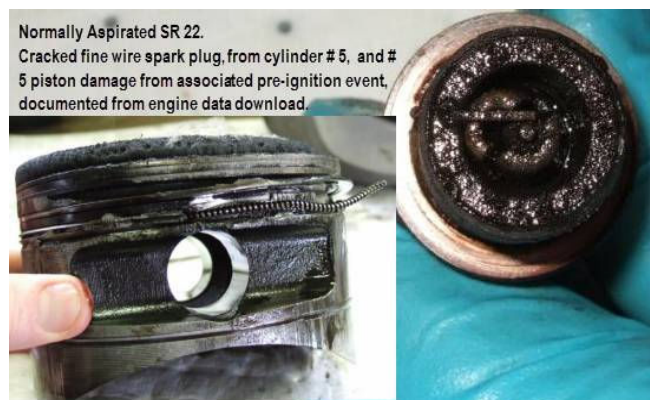
Figure 2. See associated engine monitor data in Figure 4, below.

Figure 2 (above) is an example of another cracked RHB32S fine wire plug and associated damage to the piston from preignition. The preignition on cylinder # 5 is clearly documented in the downloaded engine data. See Figure 4.

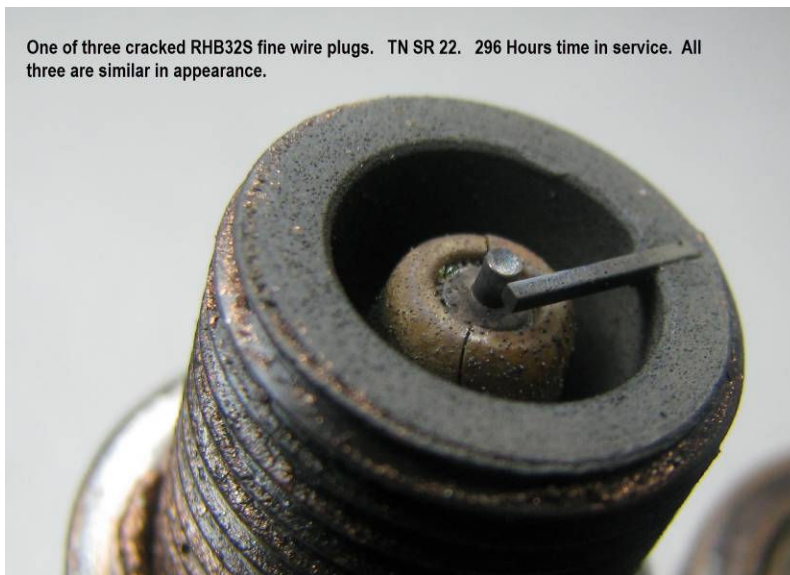
Figure 3.

One of three cracked RHB32S fine wire plugs. TN SR 22. 296 Hours time in service. All three are similar in appearance.

The cracks in this example are obvious. However, in some instances, cracks may only be visually detectable after the spark plugs are cleaned in accordance with normal shop practices.

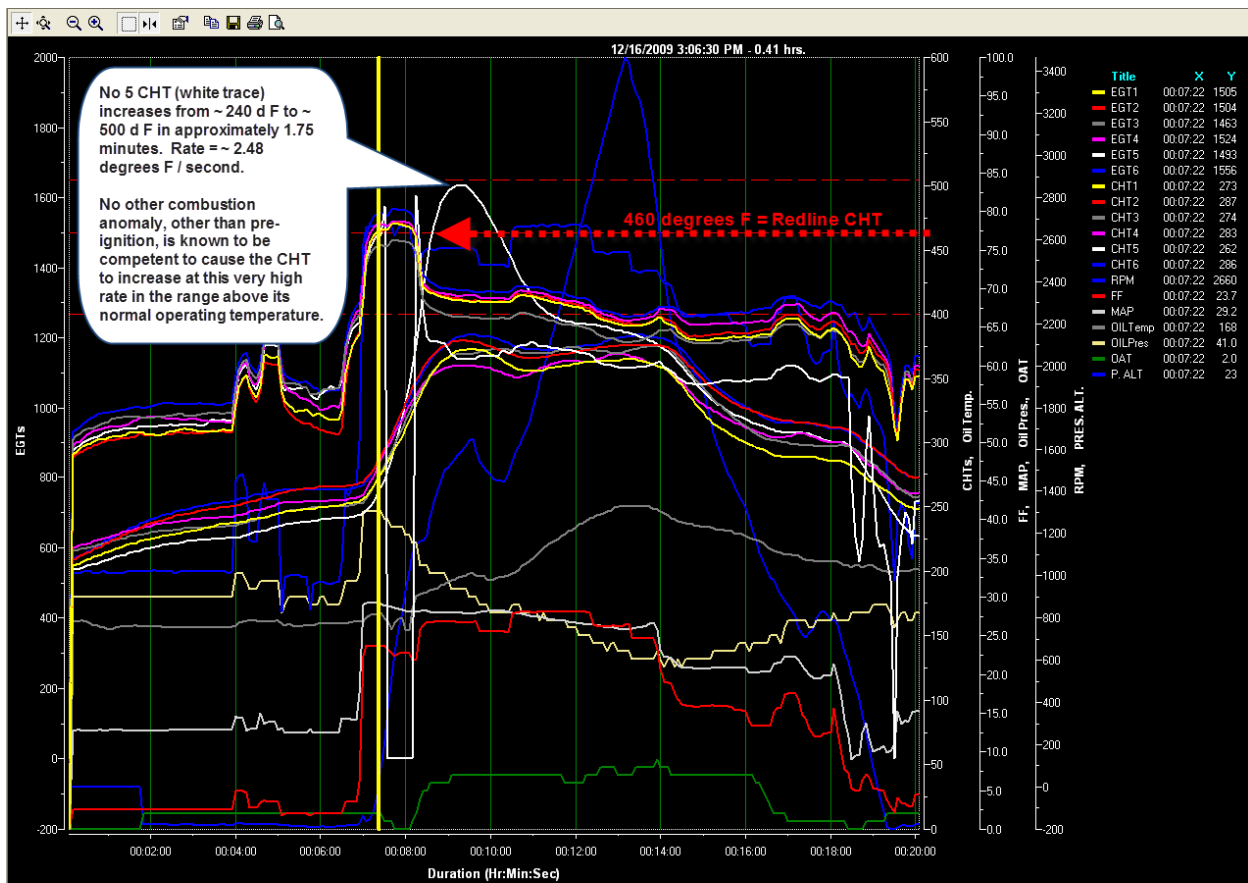
Figure 4.

Downloaded engine data from the two incident aircraft and from the non-injury accident aircraft is strongly consistent with preignition events as the cause of the two incidents and the accident. In no case has the affected cylinder been operating at higher than normal cruise cylinder head temperatures (CHT) when the preignition events began in the affected cylinder. The modest initial operating CHT precludes consideration of other abnormal combustion events, such as detonation. The only abnormal combustion events that fit the data are preignition type combustion events.

CORRECTIVE PILOT ACTION: In the event a very rapid and unusual rise in any CHT is observed, the pilot should (altitude permitting) immediately reduce the power with the throttle to idle for 3 to 5 seconds and then advance the power with a full rich mixture to the minimum power level required to maintain flight. Thereafter, land at the first available opportunity and ground the aircraft until the cause is determined and corrected. Performing this corrective action before the CHT exceeds the normal engine redline CHT (500 degrees F) will likely, but not necessarily, prevent significant damage to the engine.
