Service Bulletin

TAT SB08-01

Issued: February 8, 2008
Model SR22 w/ Tornado Alley
Turbo, Inc. Turbonormalizer
installed pursuant to Engine
Technologies, Inc. STC
SA10588SC on Cirrus Design
Corporation Model SR 22 aircraft

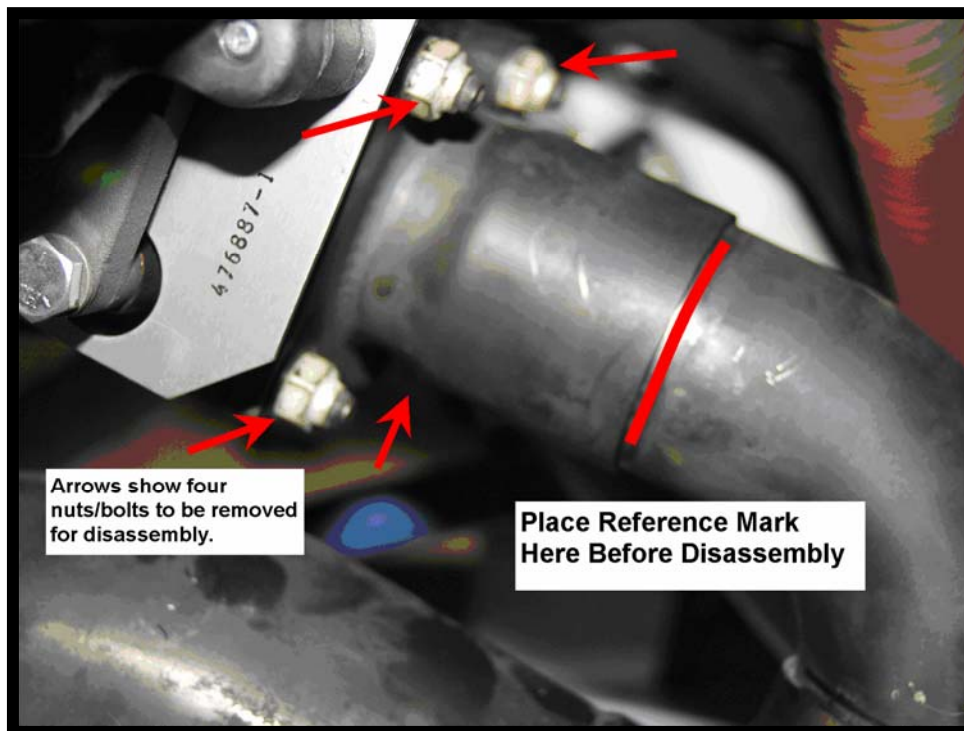
Figure 2.
Left side.
Showing where to
place reference
mark before
disassembly.

- d. Clean the area where the elbow is inserted into the wastegate outlet tube.
 - e. Mark the exhaust elbow at the aft end of the wastegate outlet tube.

Using the same instructions and technique described above for Group A aircraft, accomplish the same inspection and modification for BOTH THE RIGHT AND LEFT side wastegate outlet elbows.
