Service Bulletin

TAT SB11-05, Revision None

Model SR22 w/ Turbonormalizer

Installed per STC SA10588SC

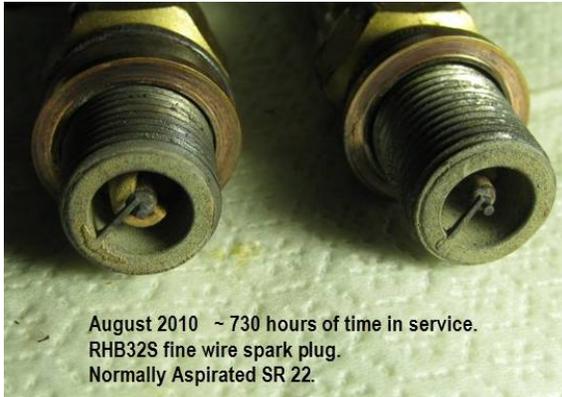
Figure 1.

Figure 1 is an example of two cracked fine wire RHB32S spark plugs from one engine.

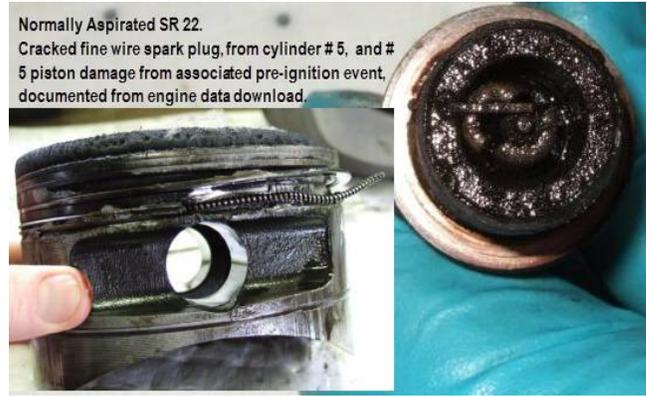
Figure 2. See associated engine monitor data in Figure 4, below.

Figure 2 (above) is an example of another cracked RHB32S fine wire plug and associated damage to the piston from pre-ignition. The pre-ignition on cylinder # 5 is clearly documented in the downloaded engine data. See Figure 4.

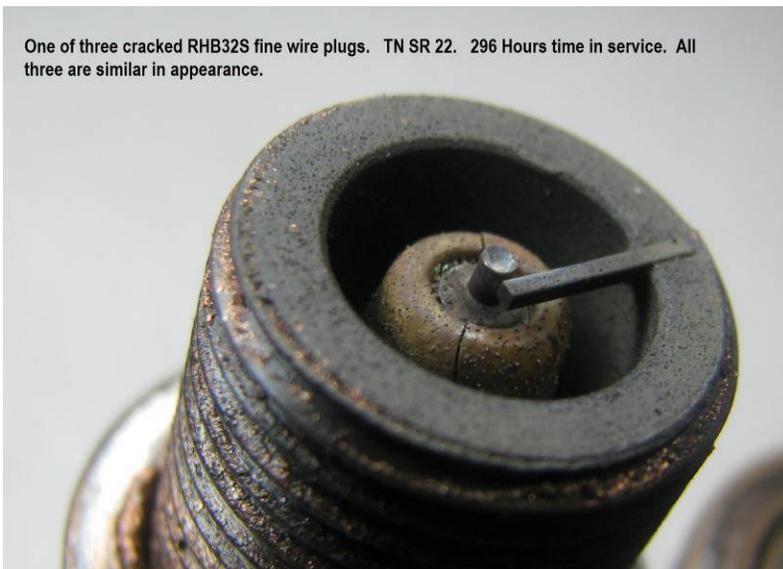
Figure 3.

Note, the cracks in this example are obvious. However, in some instances, cracks may only be visually detectable after the spark plugs are cleaned in accordance with normal shop practices.

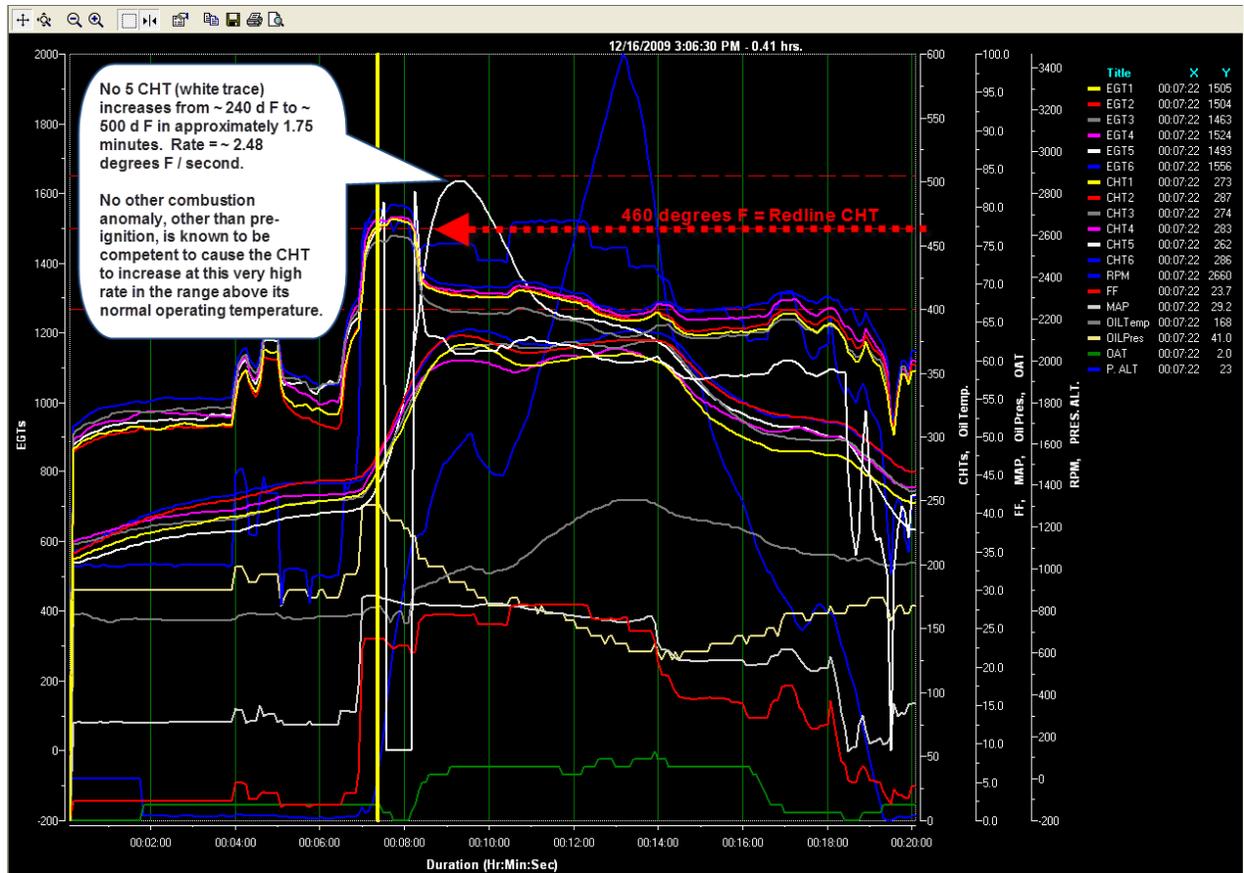
Figure 4.

A cracked spark plug ceramic, in some cases, creates a hot spot on the spark plug that results in ignition of the fuel/air mixture early in the compression stroke and well in advance of the normal spark event. This pre-ignition at normal cruise to high power settings creates extremely high CHTs in a very short time, on the order of 30-60 seconds. See Figure 4 which details this event in connection with the damaged cylinder shown in Figure 2, above. This rapid (≈ 1.5 to 3.5 degrees F / second) increase in cylinder head temperatures, if not corrected immediately, may cause, and has caused destruction of piston rings and pistons. See Figure 2, above. This piston and ring damage will normally cause the crank case to become pressurized from the pumping action of the piston and oil can then be forced out of the crank case breather until the engine oil pressure drops to zero. This may lead to engine stoppage and a forced landing.

CORRECTIVE PILOT ACTION: In the event a very rapid and unusual rise in any CHT is observed, the pilot should (altitude permitting) immediately reduce the power with the throttle to idle for 3 to 5 seconds and then advance the power with a full rich mixture to the minimum power level required to maintain flight. Thereafter, land at the first available opportunity and ground the aircraft until the cause is determined and corrected. Performing this corrective action before the CHT exceeds the normal engine redline CHT (460 degrees F) will likely, but not necessarily, prevent significant damage to the engine.
