# Service Bulletin

TAT SB08-02

Model SR22 w/ Turbonormalizer

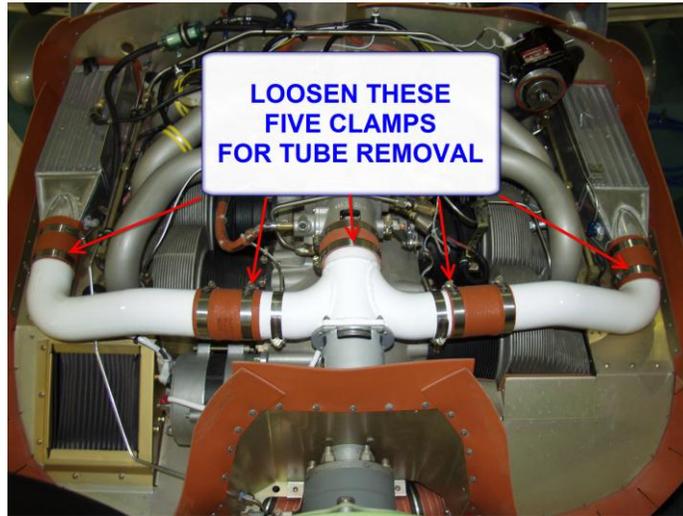
**Figure 1 shows five clamps to be loosened to remove PRV/Y tube**

- Gain access by removing the upper portion of cowl.
- Loosen clamps on induction couplings in five areas:
  1. Clamp closest to PRV/Y tube on coupling between PRV/Y tube and throttle body.

2. Clamp closest to PRV/Y tube on coupling between L/H induction tube and PRV/Y tube.
  3. Clamp closest to PRV/Y tube on coupling between R/H induction tube and PRV/Y tube.

4. Clamp closest to L/H induction tube on coupling between L/H induction tube and L/H intercooler.
  5. Clamp closest to R/H induction tube on coupling between R/H induction tube and R/H intercooler.

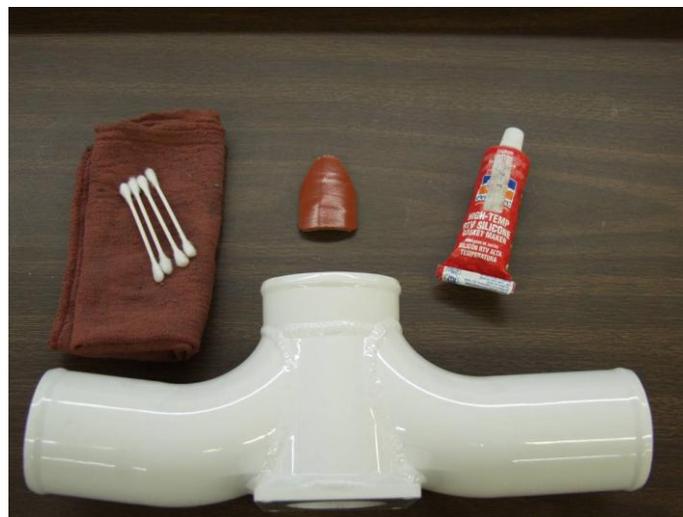
**Figure 2 shows all material needed to attach the Anti-Wear Pad to the PRV/Y tube**

PRV/Y Induction Tube	ETI-SR22-200-M2-1	1 ea
Anti-Wear Pad	22-6100025	1 ea
Red RTV Silicone	Not Provided	
Cotton Swabs	Not Provided

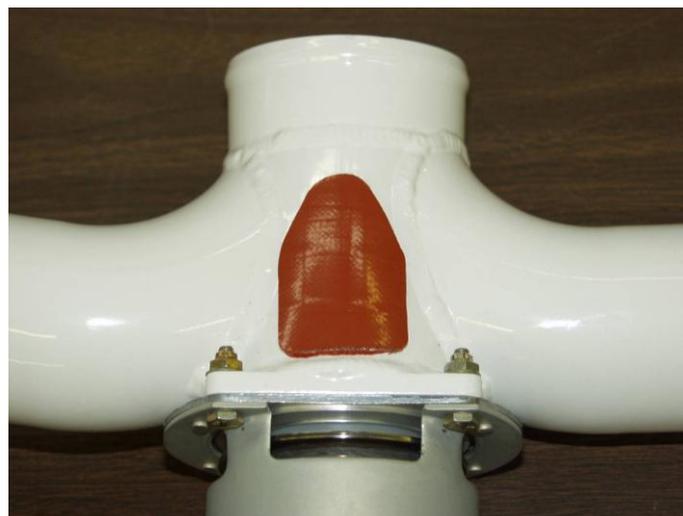
**Figure 3 shows the Anti-Wear pad properly attached to the underside of the PRV/Y tube.**

- Apply Red RTV Silicone to the underside of the pad. Spread the glue evenly over the entire surface.
- Set the pad on the clean surface of the tube with the flat base of the pad up against, but not on top of the weld bead for the PRV flange.

- Apply pressure to the entire surface of the pad to ensure complete adhesion of the pad to the tube.
- There will be extra glue that squeezes from under the pad and collects at the sides of the pad. Use a cotton swab to clean up the extra glue.

- Set the tube somewhere where it can sit undisturbed for the next 12-24 hours to allow the silicone to fully cure.
- After the RTV silicone has fully cured, inspect the pad once more to ensure all edges of the pad are fully secured to the tube. If so, then the tube is ready to be re-installed on the engine.
